Subject: E401 Error Code

Models: FJM

Title: Outdoor Freezing Detection

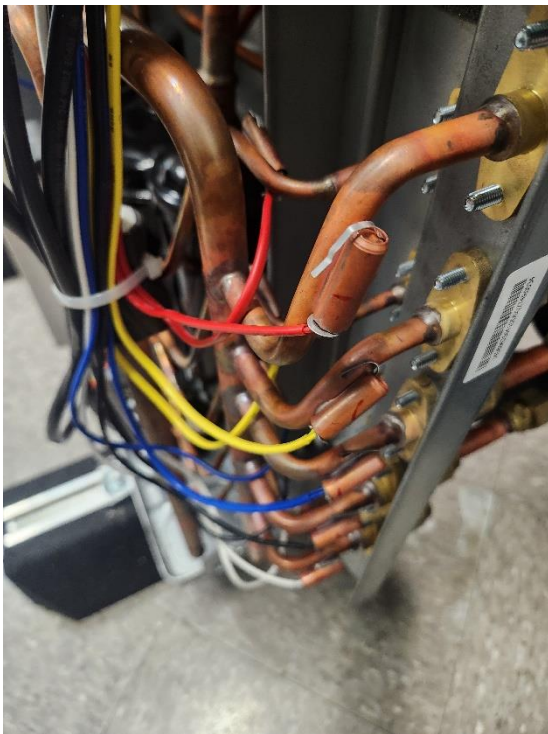
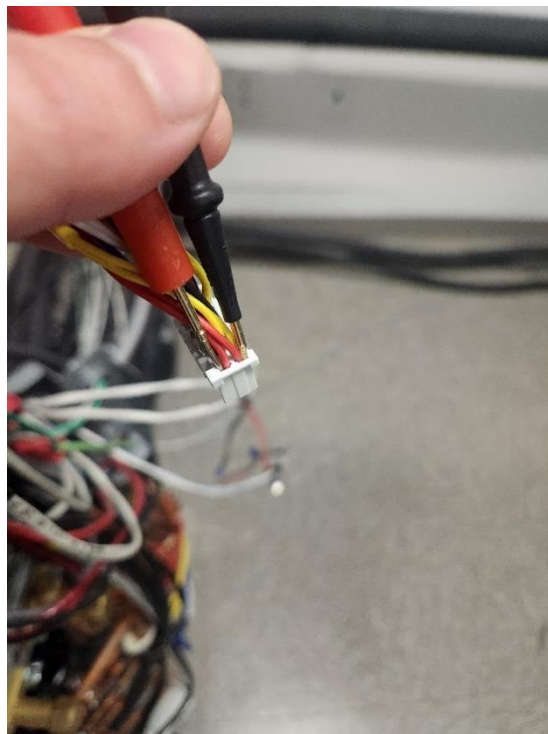
1. Ensure EVA thermistors are installed correctly on each copper line jacket and plugged in properly on PCB.
2. Power off unit for a minimum of 15-20 minutes before continuing to next step.
3. Remove thermistor harness, Ohm the sensor and compare it to the resistance chart on page 2.
4. Replace thermistor harness if reading incorrectly.
5. If thermistors are reading correctly, check refrigerant levels.
6. If refrigerant levels are accurate, replace PCB.
