**Subject:** E219 Error Code

**Models:** DVM Heat Recovery, ECO Heat Recovery

**Title:** Subcooler Inlet Temperature Sensor in MCU Open or Short

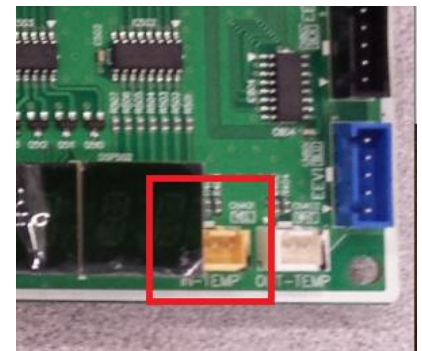
Test with needlepoint leads on the 2 silver tabs

1. Locate MCU that is in error. (E219-C100 is MCU address 00)
2. Locate the Subcooler inlet sensor at CN401 on MCU PCB.
3. Inspect the sensor and make sure it's plugged in correctly.
4. OHM the sensor and compare it to the resistance chart below, if the sensor is out of range or open, replace the sensor.
5. If the sensor tests within range, replace the MCU PCB.
