*Ducted Systems
Technical Services
Service Tips Letter*

Letter: **ST-009-2016**

Subject: **Application Engineering Observations on Errant Current Protection for Electric Motors in HVAC / Refrigeration Systems**

Product: Residential and/or Commercial products with Variable Frequency Drives (VFDs)

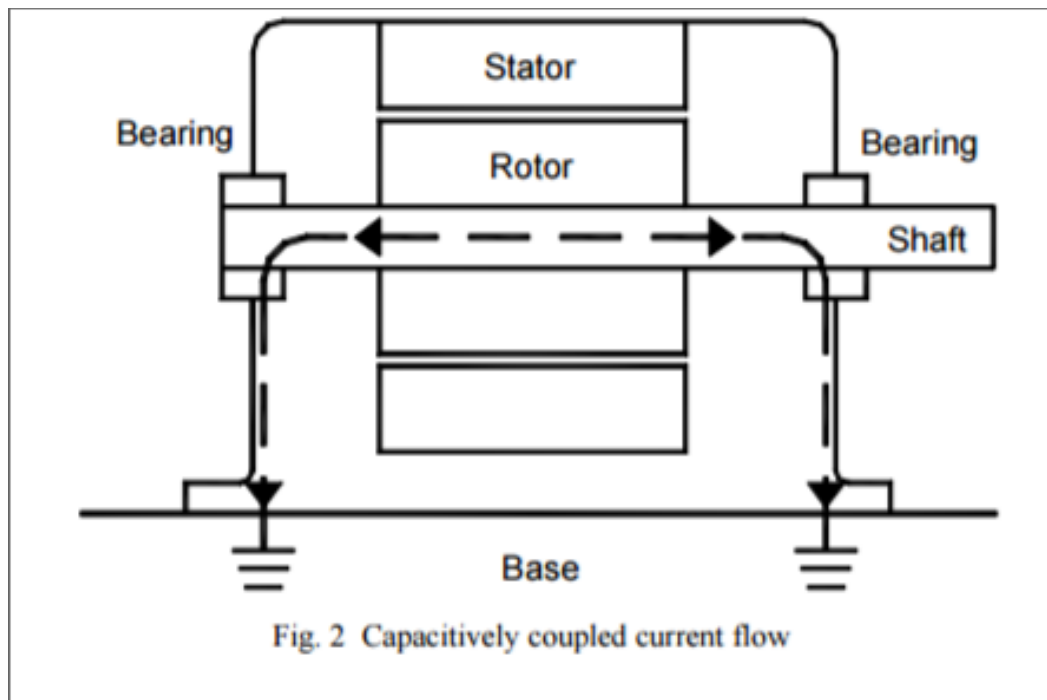
If currents are high enough, they will “leak” back through the bearing’s rotational components such as the races, balls, and rollers; they will make their way to the outer race and finally into the motor body and then to ground if connected (see Figure 2). This is electrical discharge machining (EDM) where a continuous, high-capacitance discharge is greater than the dielectric strength of the oil film within the bearing. Unless mitigation is employed for shaft voltages, the motor bearings may become damaged from the electrical currents in the form of pitting and fluting. Fluting will exhibit excessive bearing noise and eventually result in motor failure.

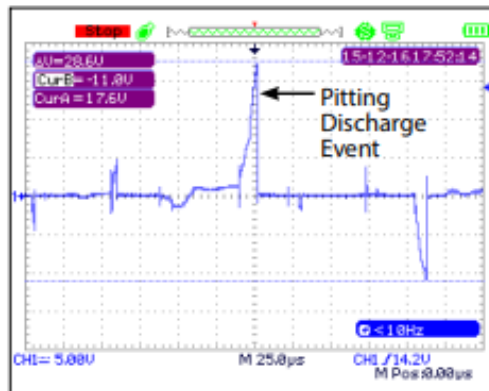
Figure 4. Source: AEGIS Bearing Protection Handbook, Edition 3 <https://www.est-aegis.com/index.php>

Note the switching speed of the drive represented in Figure 4 is 20 kHz. This means the switching by the IGBTs are running at 20,000 times per second. (AC is 60 cy per second for reference.) Every time they switch they arc.
