ECM 3.0 Motor Troubleshooting

GE ECM

Christopher Mohalley — GE ECM Master Motor Trainer

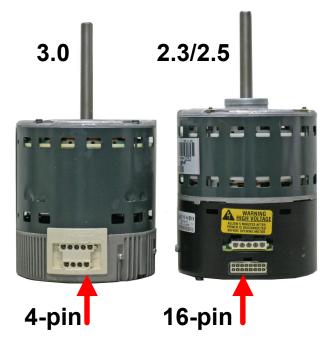
The next generation variable speed motor model 3.0 is now in the field. This model has a few notable external changes from its predecessors. The 16-pin communication connector has been replaced with a 4-pin connector, the control has been reduced in size and changed in appearance. The change to the 4-pin connector is possible due to the Digital Serial Communication (DSI) used by this control. Often called simply a "communicating motor", information is transferred between the system control board and the motor control in a manner equal to two computers or a computer connected to a peripheral such as a printer.

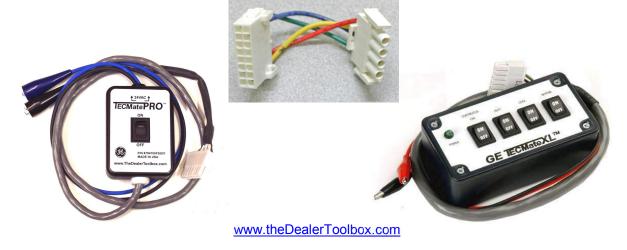
This will immediately raise the question, "How do I troubleshoot this motor"? The answer is, with your existing TECMate. We have programmed the model 3.0 to be compatible with the TECMate PRO model and the discontinued XL model. Either of these will troubleshoot a 3.0 motor with the simple use of a 16-pin to 4-pin adapter plug. This adapter can be ordered for free on our website www.theDealerToolbox.com in the "Service Tools "drawer. If you do not currently own a TECMate, the PRO model, available on the website, will come with the adapter.

If the troubleshooting process takes you to using the TECMate and you have a PRO model, the only change will be the use of the 16-4 pin adapter. If you have an XL model, other than using the adapter, the only switch on the XL that is needed to test the model 3.0 motor is the last or far right switch typically labeled "BK/PWM".

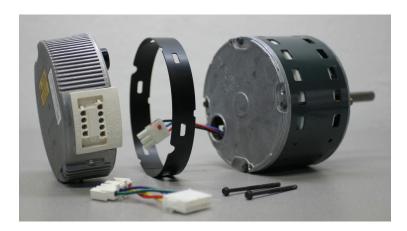
If a 3.0 control or motor needs to be replaced, like all ECM parts, they will have to come directly from the OEM (Original Equipment Manufacturer). The model 3.0 is also a direct replacement for the model 2.5 motor that will be discontinued early 2008 (used exclusively by Carrier Infinity and Bryant Evolution Systems). If a 2.5 control fails (depending on current stock levels) the replacement control will be the 3.0. Therefore, the model 3.0 control ordered from Carrier/Bryant will include a 16-4 pin adapter (the model 2.5 used the 16-pin plug) and an adapter ring with new bolts, to allow the 3.0 control to attach to the 2.5 motor. It sounds more difficult than it really is, as shown in the picture below.
