Subject: E214 Error Code

Models: DVMS Heat Recovery, ECO Heat Recovery

Title: Specified Quantity MCU on Outdoor Unit PCB Does Not Match Installed MCU Quantity

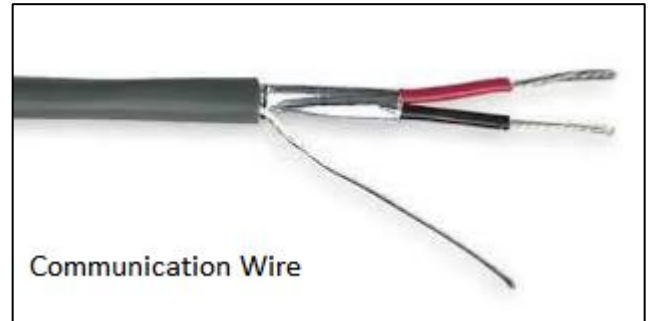
1. Verify all MCU and HR changers have 208/230Volts
2. Make sure communication wire is 16/2 stranded shielded wire
3. Verify communication wiring is a true daisy chain from condenser and land on MCU or HR changer 1st as shown in the image below. Verify there are no breaks, junction boxes or splices in comm wire.
