**Subject:** E348 Error Code

**Models:** DVM, CHILLER

**Title:** Fan Motor 2 Locked in Outdoor Unit

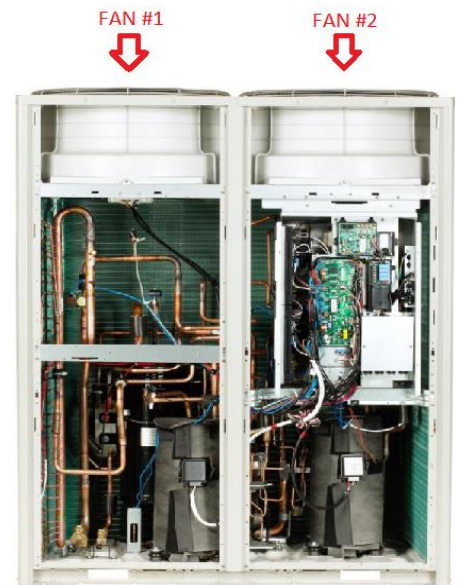
Fan 2 is on the right-hand side of the unit

1. Remove power to the condensing unit for a minimum of 15 minutes.
2. Inspect the fan blade and make sure there are no obstructions.
3. Verify blade spins freely.
4. There are two plug connections for each fan motor. Power (red, white, and black) and hall effect sensor.
5. Follow and inspect wiring. Make sure there is no damage to wires or plugs.
6. Make sure all plugs and spade connectors are secure and connected properly.
7. Disconnect power plug (Fan motor 1 is white plug, Fan motor 2 is blue plug) Check resistance at plug going to Fan motor. Red-White, Red- Black and White to Black. The resistance value between each winding should be equal, under 10Ω and open to ground

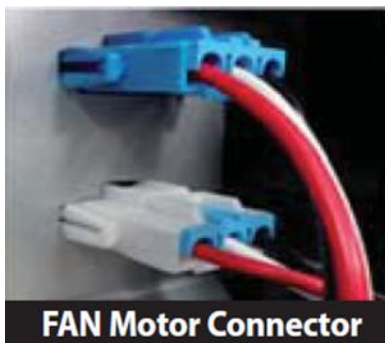
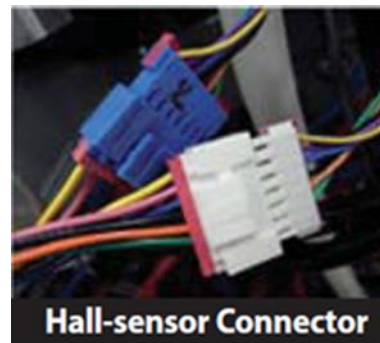
Fan #2 is on the left-hand side of unit

1. Reverse connector plugs for Fan motor 1 and Fan motor 2. (Fan Motor and Hall Effect plug)
2. Restore power to the unit. If the E348 error returns, replace fan PCB. If the error changes to E448, replace the fan motor.

1. Remove power from unit for minimum of 15 minutes. Remove Fan connections from Fan PCB and connect inverter checker.
2. Restore power to unit. Press K2 button 12 times to initiate the inverter test for fan motor 2.
3. If the inverter test fails, replace Fan PCB. If it passes, replace Fan motor.
