Subject: E389 Error Code

Models: DVM, CHILLER

Title: Outdoor Unit Fan Motor 2 Stopped Due to Overload (V-Limit)

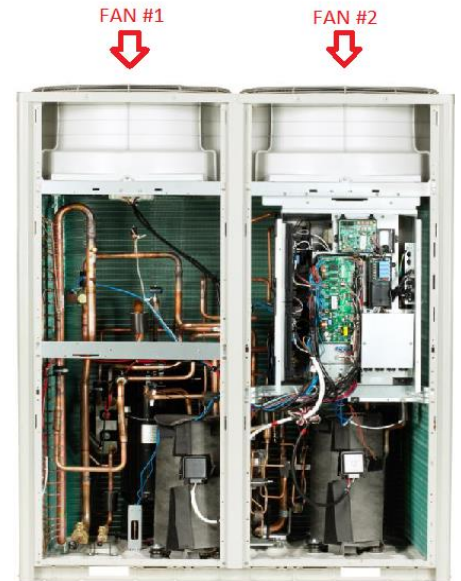
Fan 2 is on the right-hand side of unit

Fan #2 is on the right-hand side of unit

1. Remove power to the condensing unit for a minimum of 15 minutes.
2. Inspect the fan blade and make sure there are no obstructions.
3. Verify blade spins freely.
4. There are two plug connections for each fan motor. Power (red, white, and black) and hall effect sensor.
5. Follow and inspect wiring. Make sure there is no damage to wires or plugs.
6. Make sure all plugs and spade connectors are secure and connected properly.
7. Disconnect power plug (Fan motor 1 is white plug, Fan motor 2 is blue plug) Check resistance at plug going to Fan motor. Red-White, Red- Black and White to Black. The resistance value between each winding should be equal, under 10Ω and open to ground
